TEST REPORT

Sample Name: Stainless steel Cable Gland

Sample Model: NPTS3/4N-18/L=14MM

1. Test item: IPX5

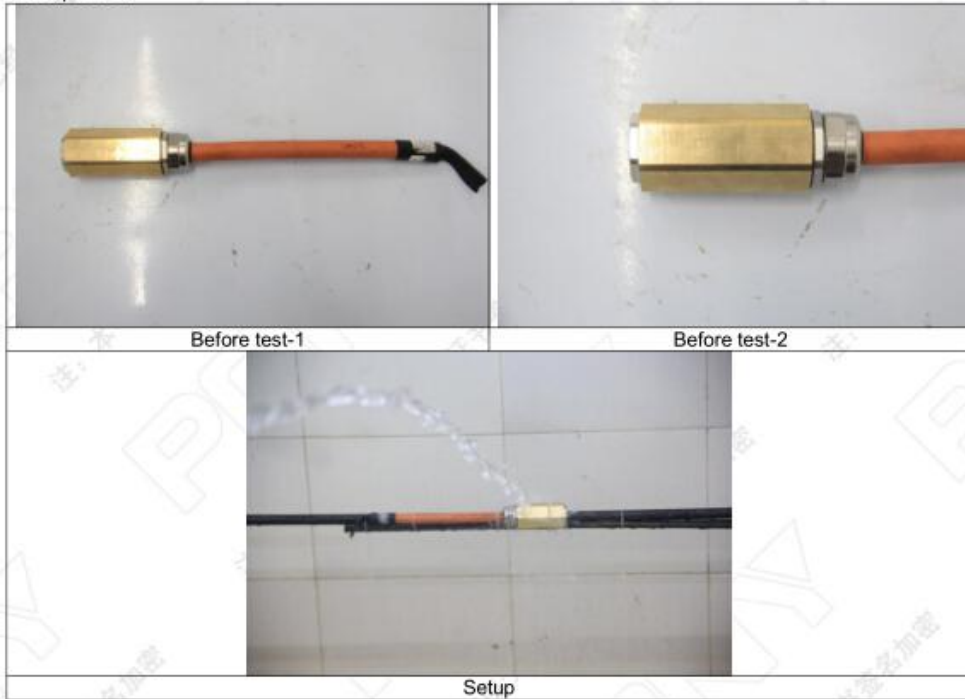
Test photos:

Test condition: Waterproof IPX5: Nozzle diameter 6.3mm, Distance 3m, Water flow 12.5L/min, Test time 3min

Sample No.	Test result
X28658720	After test, there is no water in the sample after the test.
